INDIANA DEPARTMENT OF ENVIRONMENTAL MANAGEMENT
We make Indiana a cleaner, healthier place to live

Re: Gary Development Company Landfill
RCRA Docket No. RCRA-V-W-86-R-45
EPA I.D. No. IND 077 005 916

On November 19, 1996, a visit to the above-captioned site was made by myself and Mr. Kirk Maravolo of the Indiana Department of Environmental Management, representatives of U.S. EPA Region V, and Mr. Steve Cherry and Ms. Lisa McKinney from Bose, McKinney & Evans. Enclosed, as previously requested, are two (2) additional photographs that were obtained by Mr. Maravolo during this visit.

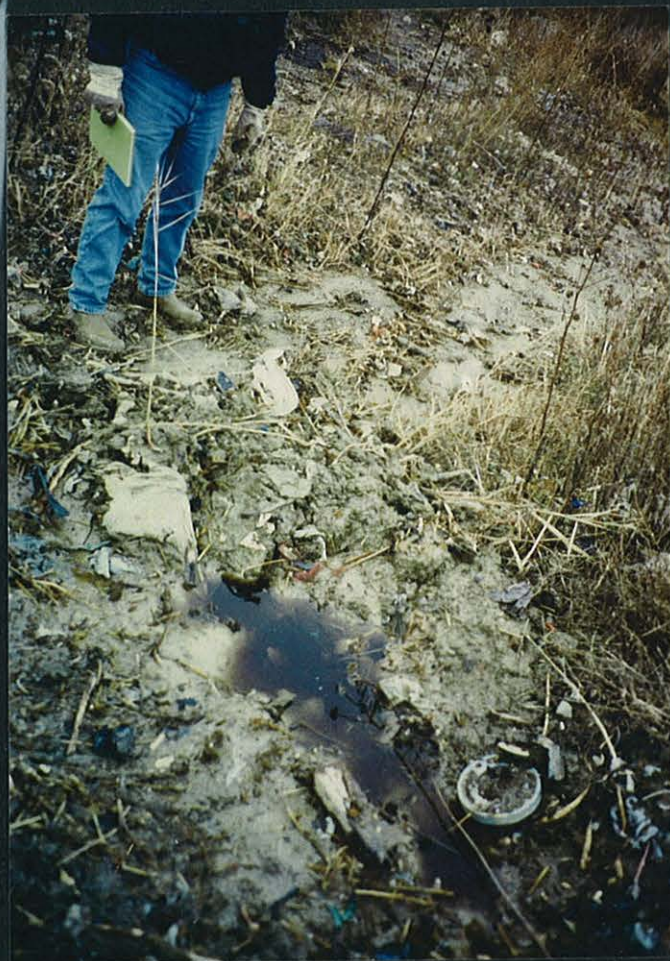
11-19-96 KIRK MARAVOLO, IDEM
GARY DEVELOPMENT LANDFILL
#1 - LEACHATE OUTBREAK AT
NORTH FACE OF LANDFILL. (BLACK
COLOR, FOUL ODOOR.) ✓

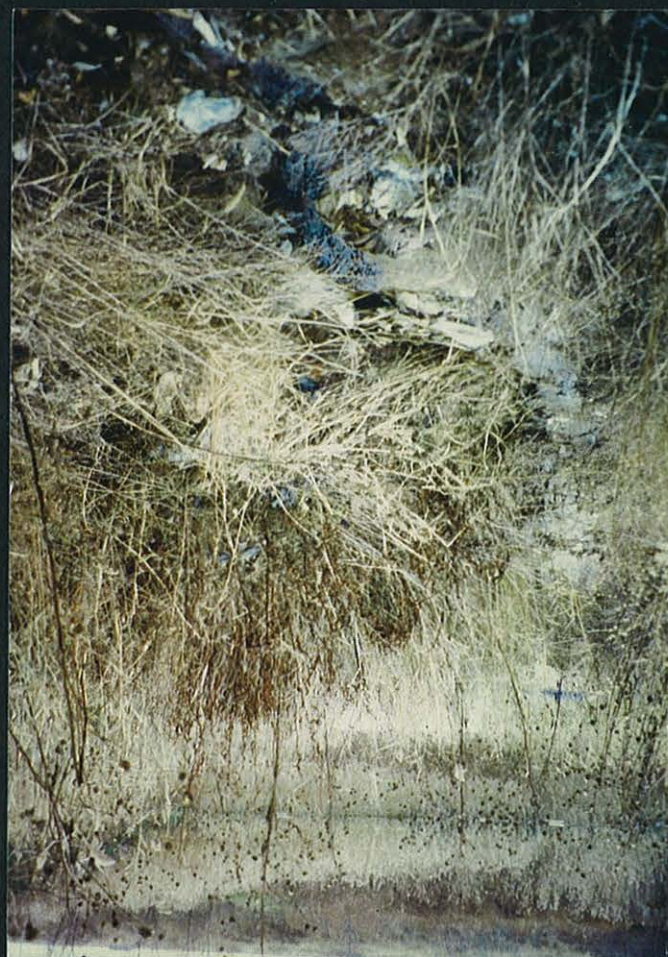
11-19-96 KIRK MARAVOLO, IDEM P
GARY DEVELOPMENT LANDFILL
#2 - FLOW OF LEACHATE TOWARDS
STORMWATER / LEACHATE POND FROM
OUTBREAK ON N. FACE OF LANDFILL

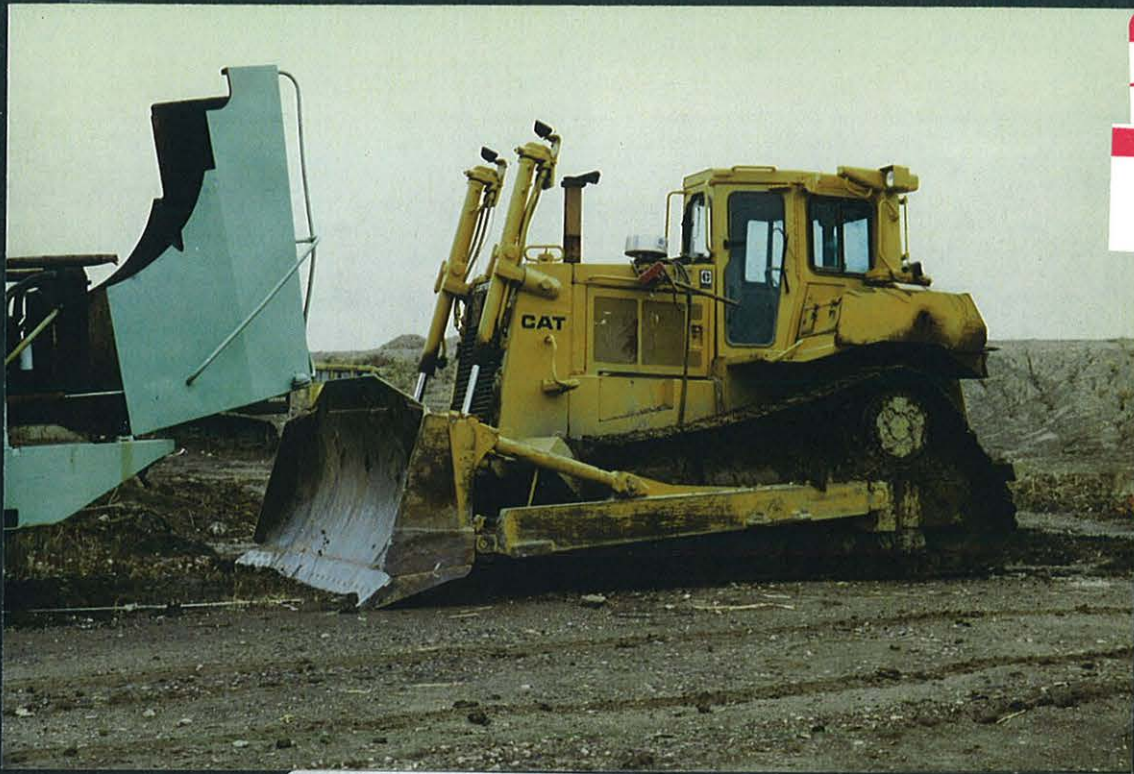
11-19-96 M. Mikulka
Gary Development Landfill
#1 -- Existing bulldozer at site

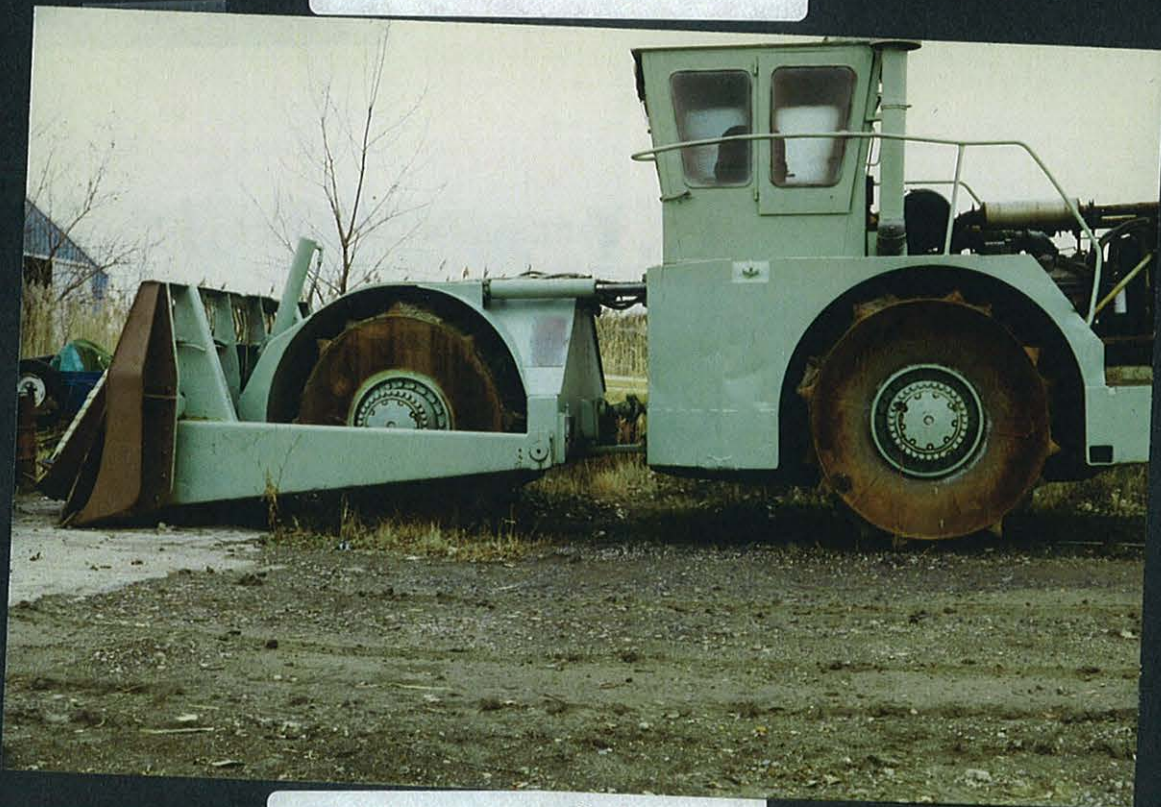
11-19-96 M. Mikulka
Gary Development Landfill
#2 -- Existing compactor at site

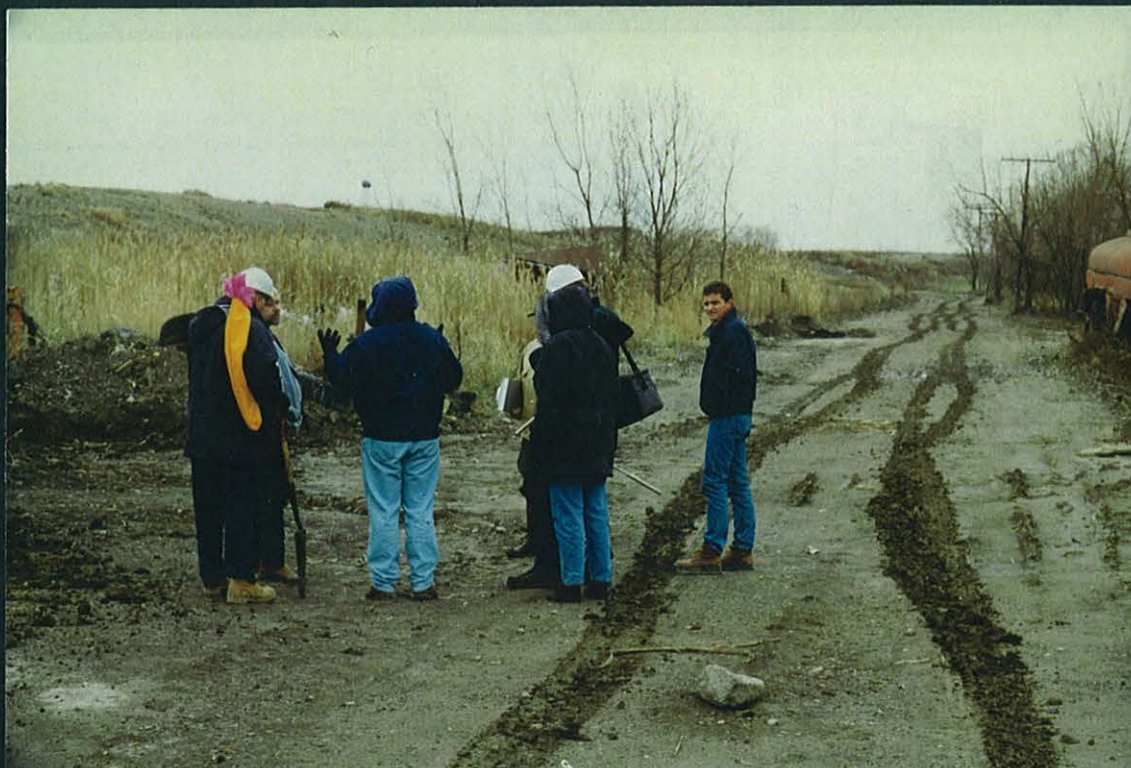
11-19-96 M. Mikulka
Gary Development Landfill
#3 Inspection team on road at GDC.
View from W to E, on S side of
LF. Steve Cherry, atty. For GDC
facing

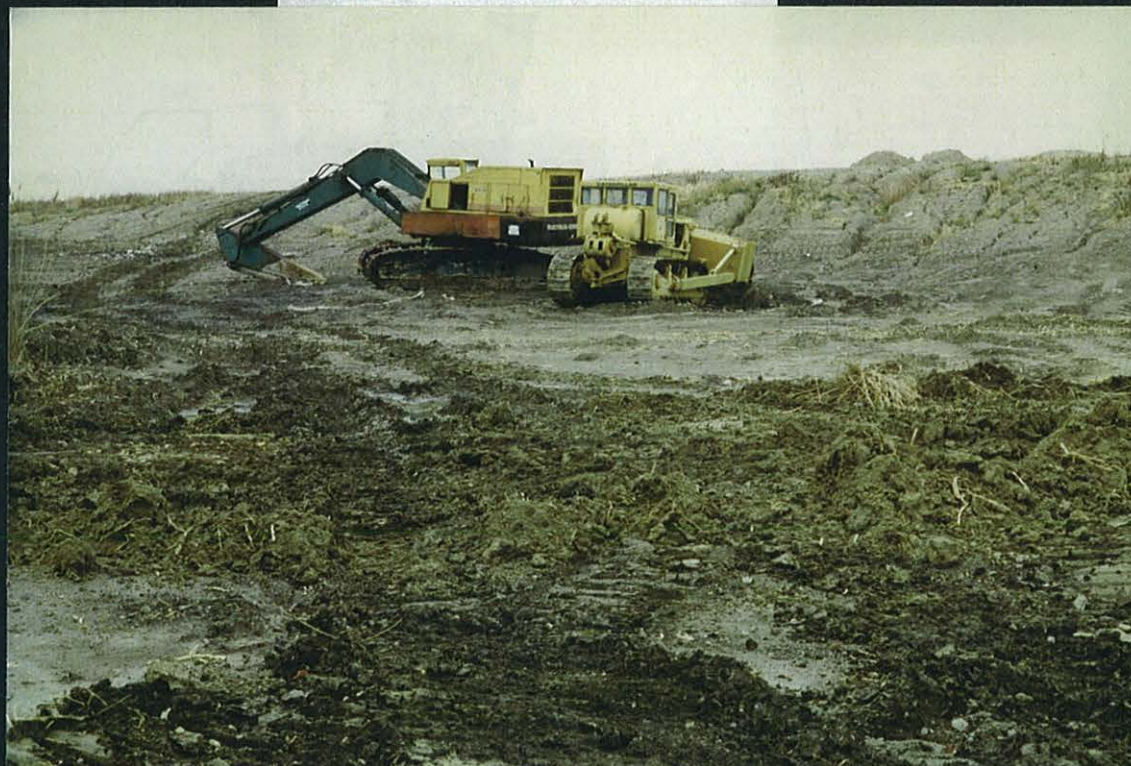
11-19-96 M. Mikulka
Gary Development Landfill
#4 -- Heavy equipment at site
location proposed for storm water
management basin. Note heavy
erosion of site slopes in

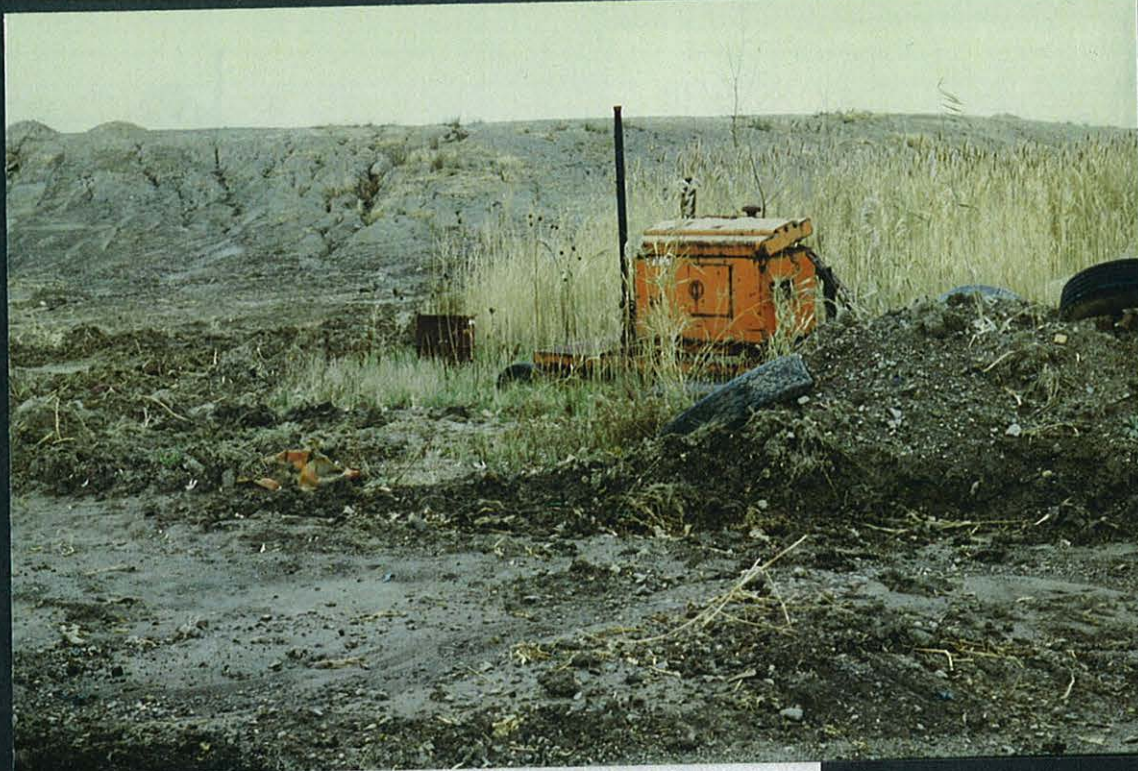
11-19-96 M. Mikulka
Gary Development Landfill
#5 -- solid waste (dirt and tires)
dumped at site. Old equipment
apparently abandoned. Note site
erosion.

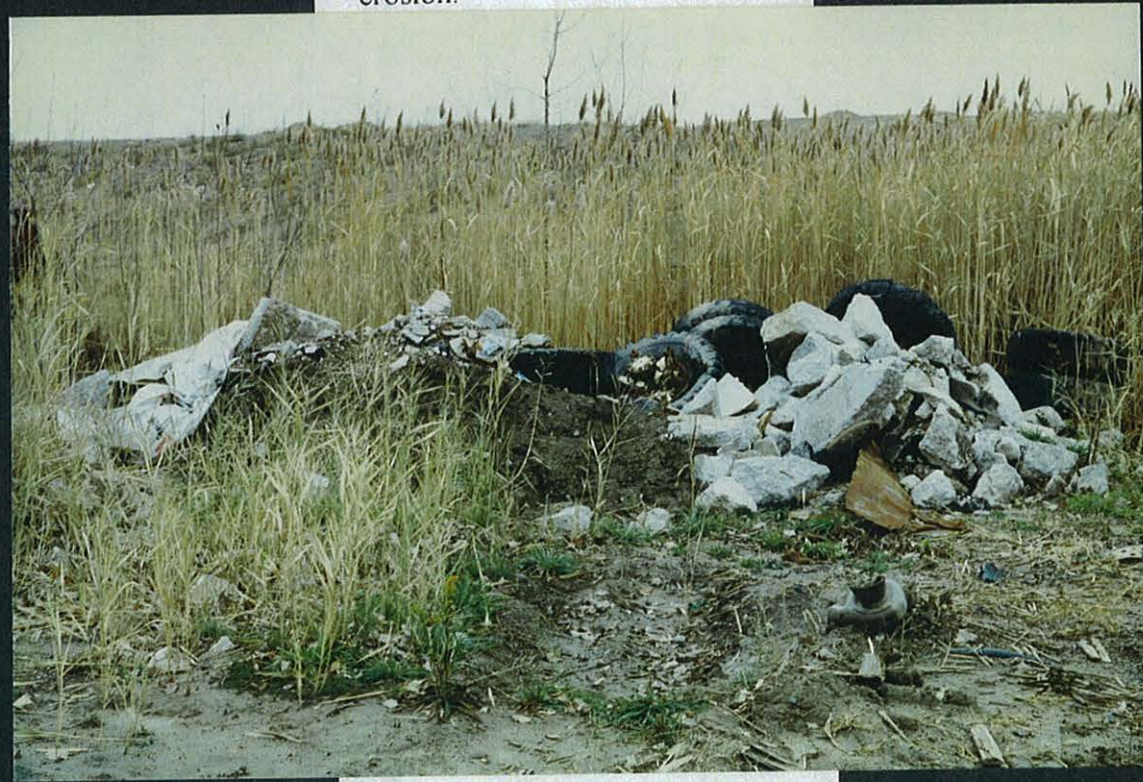
11-19-96 M. Mikulka
Gary Development Landfill
#6 -- Concrete rubble and tires
dumped along road at site.

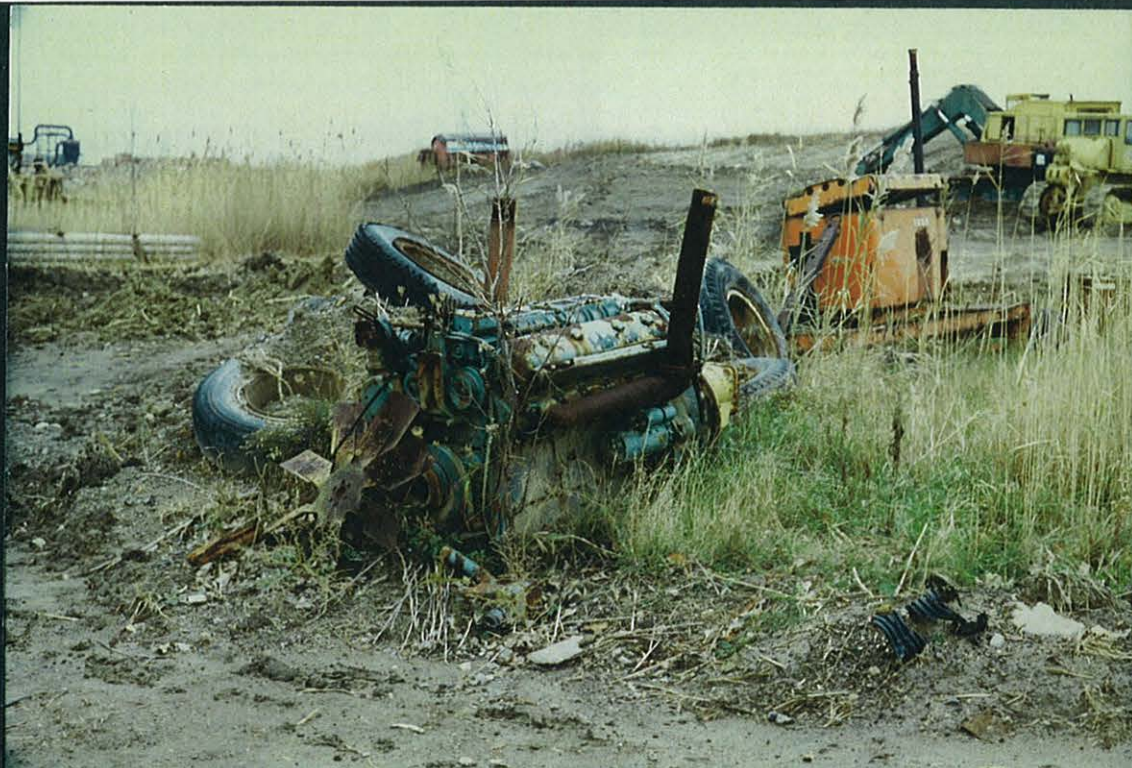
11-19-96 M. Mikulka
Gary Development Landfill
#7 -- old engine and tires at site.
View from road on S side towards
NW.

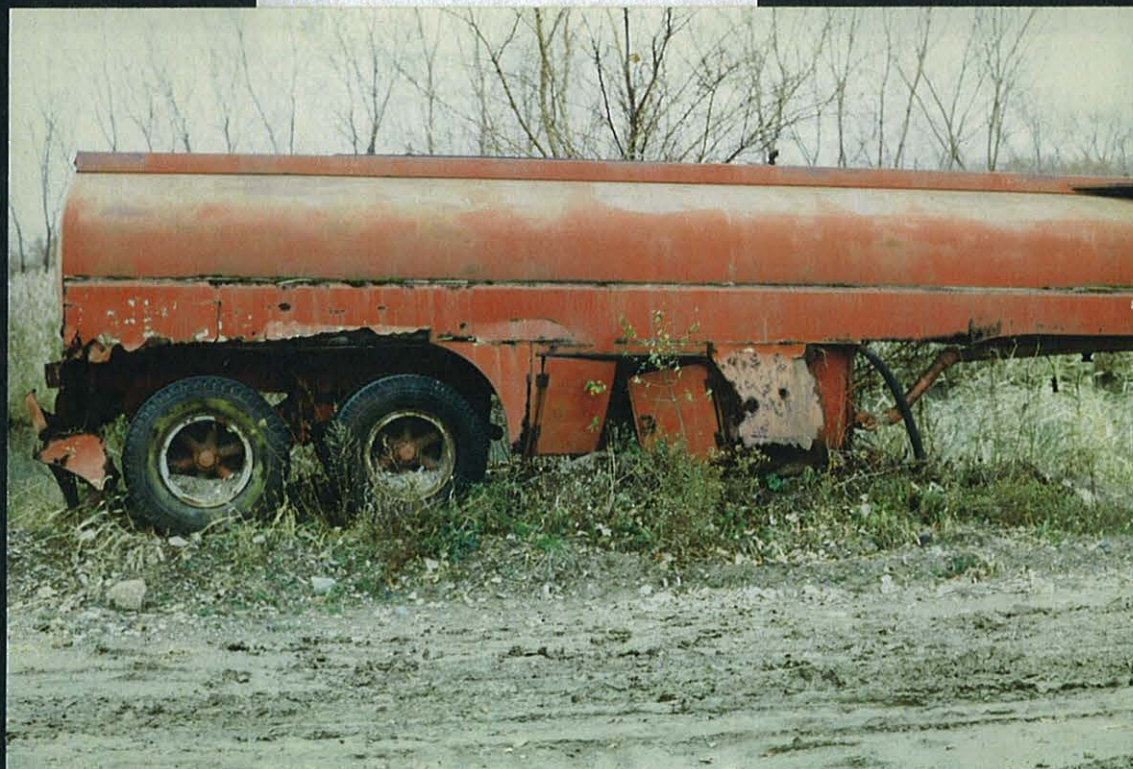
11-19-96 M. Mikulka
Gary Development Landfill
#8 -- Trailer abandoned at site on
S side of road. River behind.

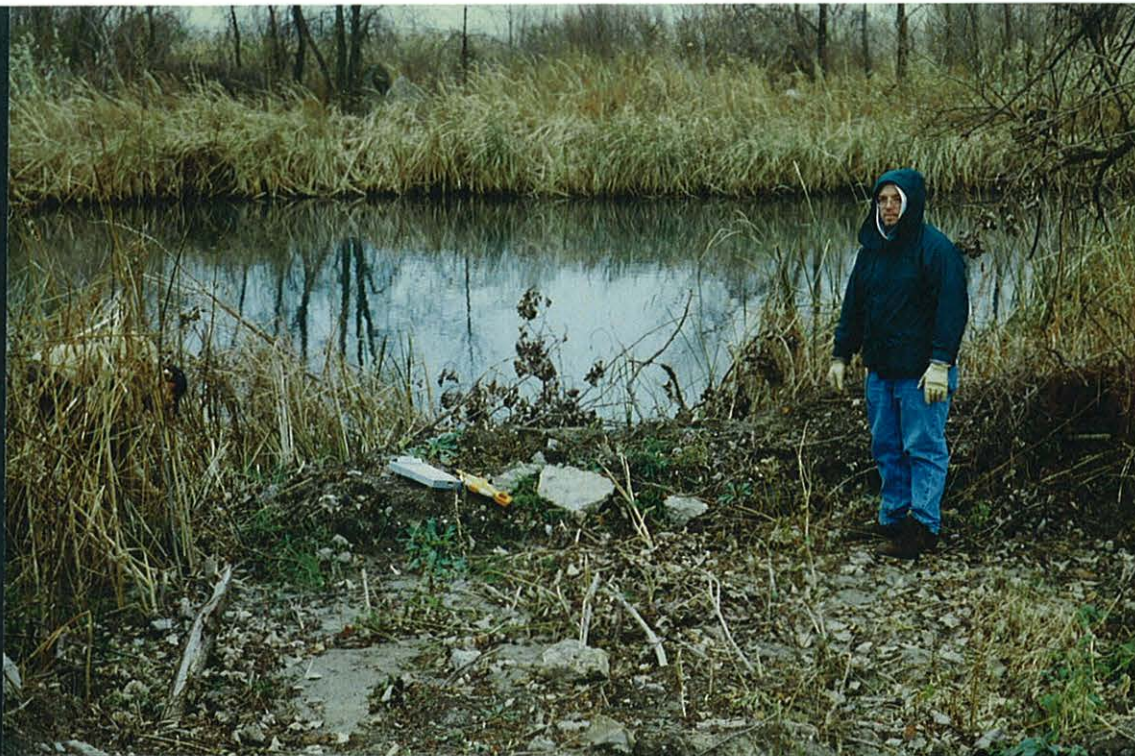
11-19-96 M. Mikulka
Gary Development Landfill
#9 -- Concrete and dirt dumped
near Grand Calumet River at site.
Kurt Maravolo, IDEM inspector
adjacent.

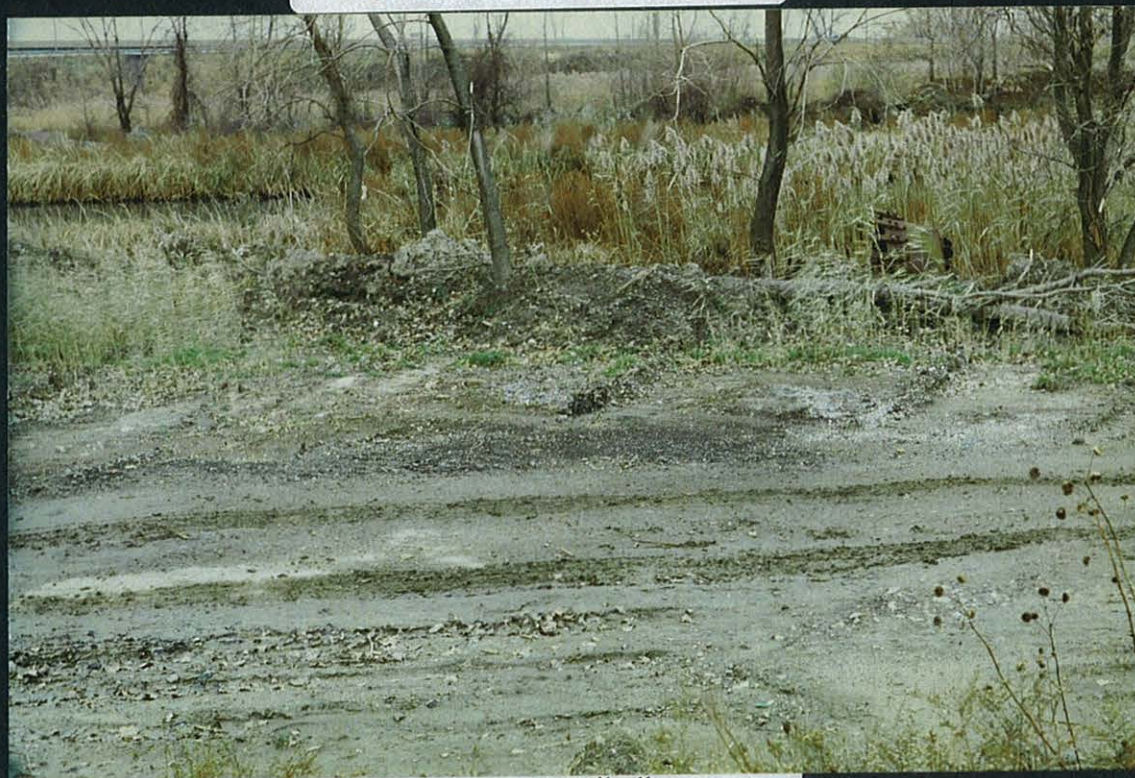
11-19-96 M. Mikulka
Gary Development Landfill
#10 -- Material pushed into
wooded wetland area at site.
View from road at GDC towards
Grand Calumet River.

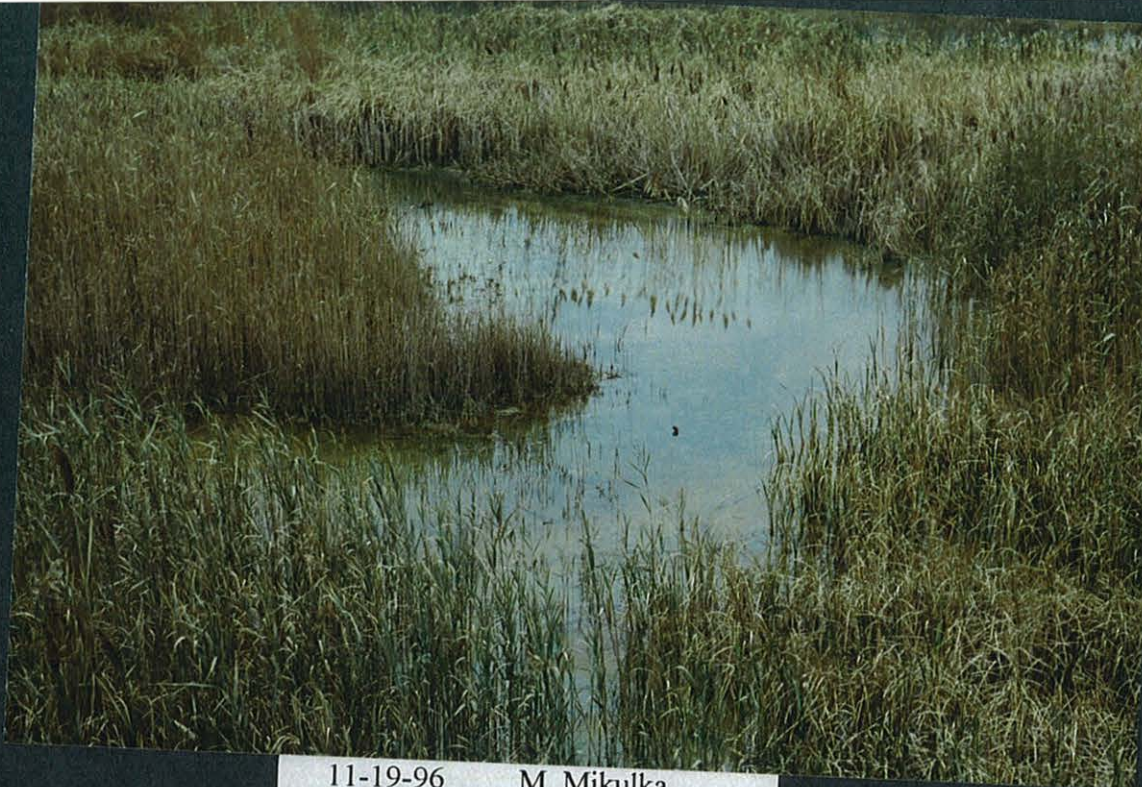
11-19-96 M. Mikulka
Gary Development Landfill
#11 -- View of ponded area on S
side of road at site, at point where
road elevates to top of landfill.
Ponded area acts a sedimentation
basin prior to flow into GCR.

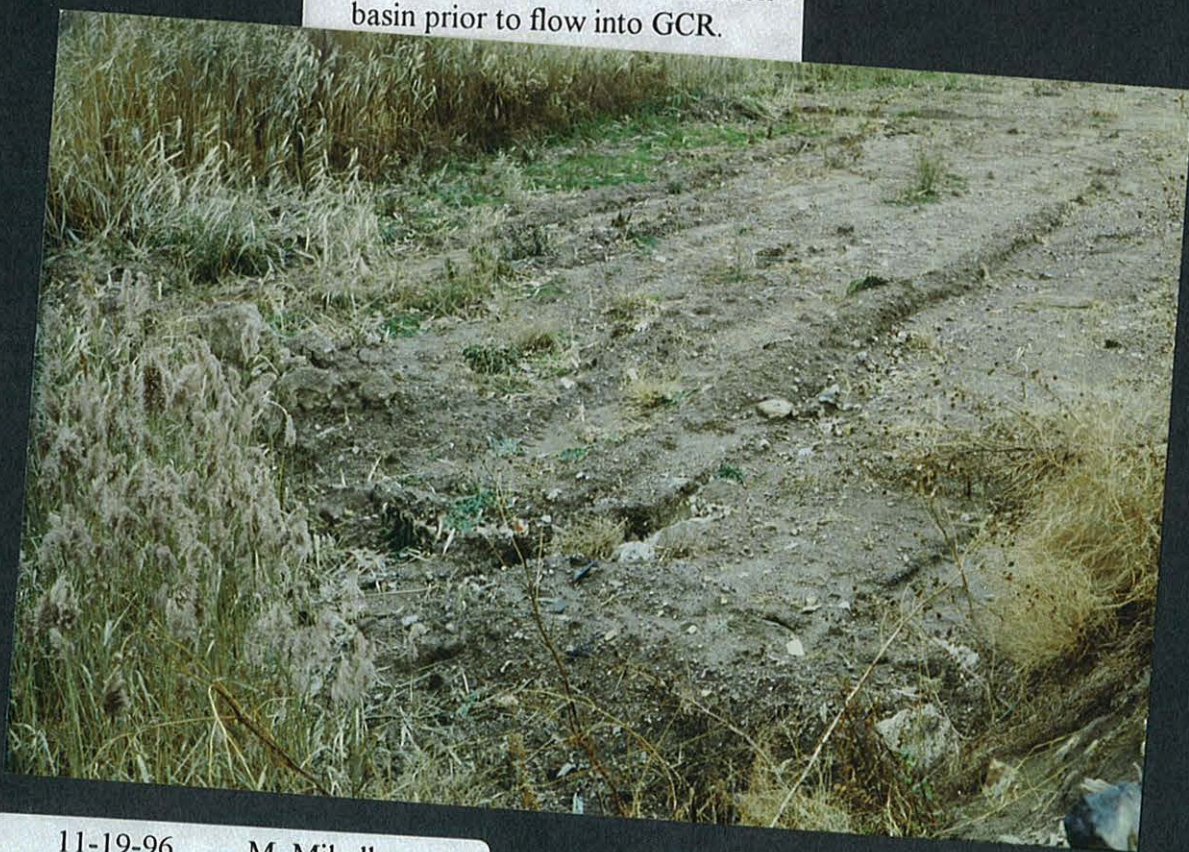
11-19-96 M. Mikulka
Gary Development Landfill
#12 -- View of area graded from
road at site into ponded area seen
in photo #11. Berm, which has

been breached, not visible in
photo. Runoff from road drains
down this slope.

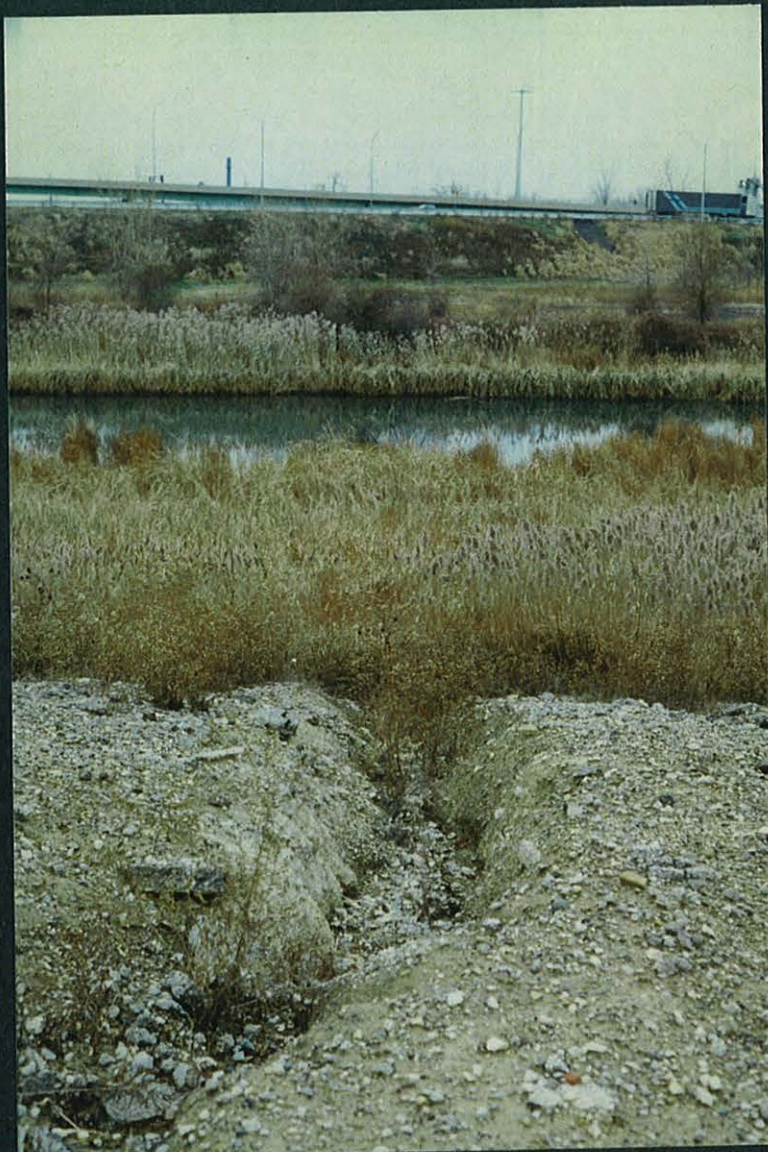
11-19-96 M. Mikulka
Gary Development Landfill
#13 -- Deep ravine caused by
surface runoff; estimated depth,
2'. Runoff drains towards
wetlands area @ SE side of
landfill. GCR in background.

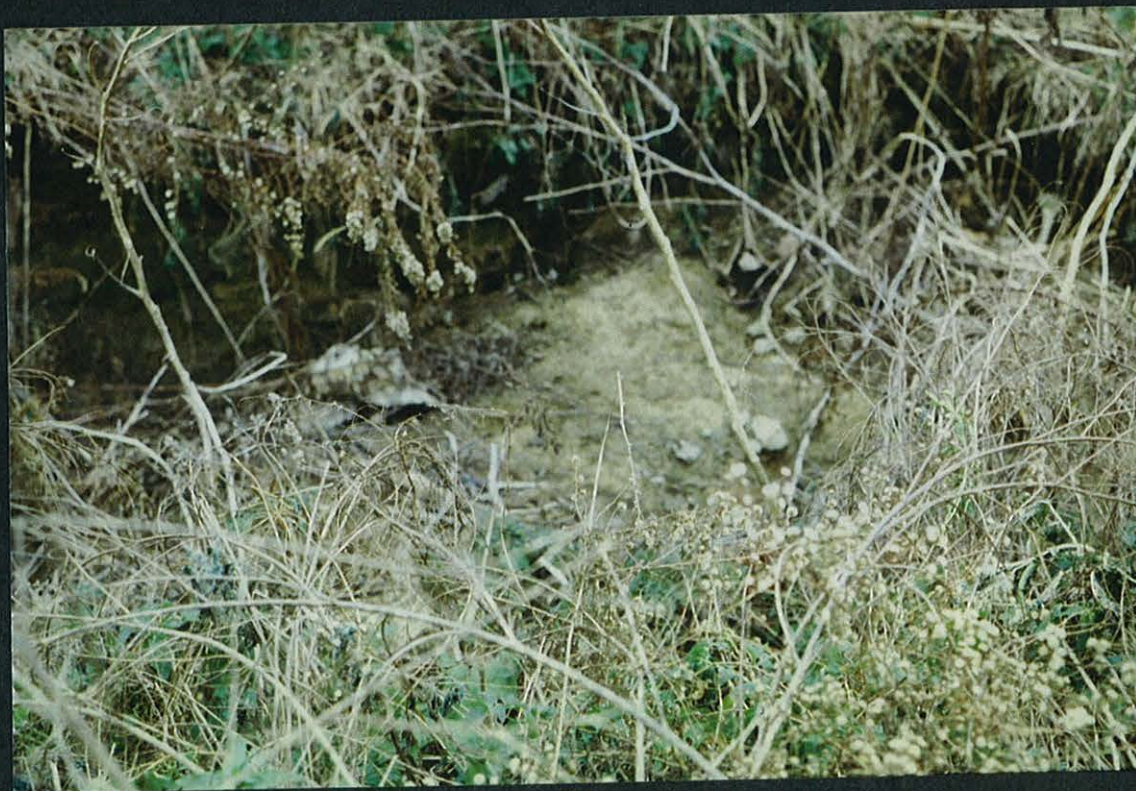
11-19-96 M. Mikulka
Gary Development Landfill
#14 -- View of ditch on E. Side of
Property. Heavily eroded, but
overgrown. Ditch conveys runoff
from E. Side of Property to
wetlands area/GCR.

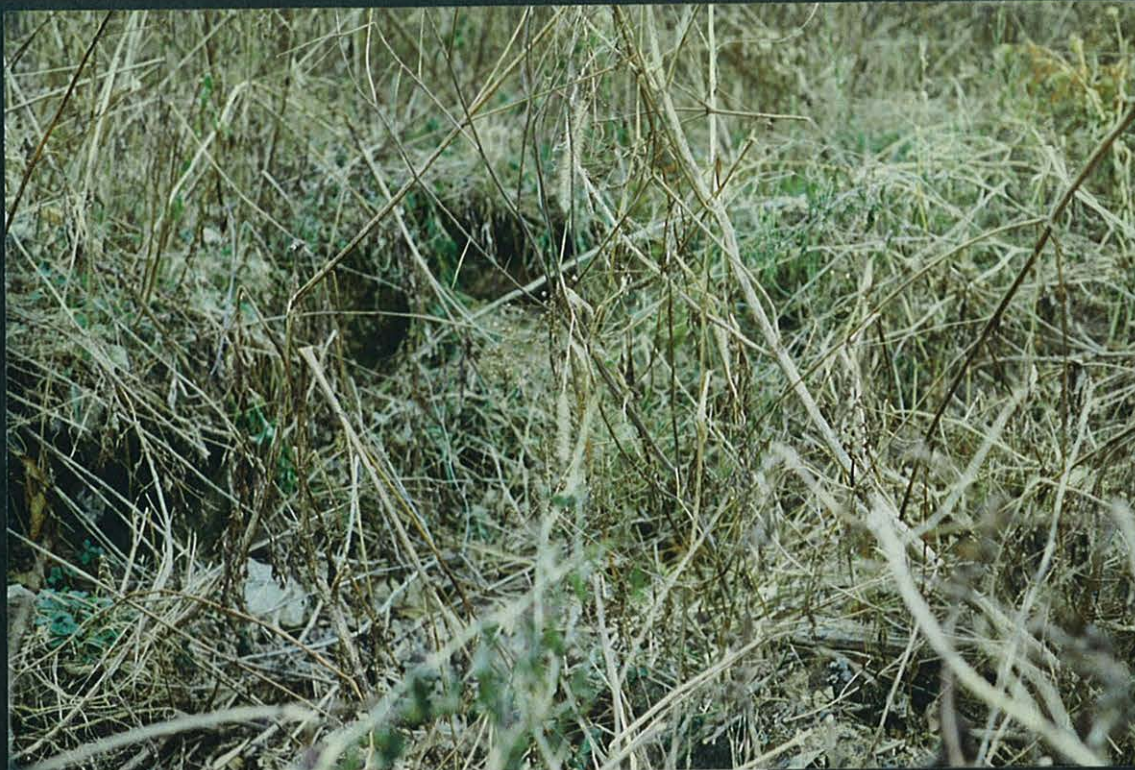
11-19-96 M. Mikulka
Gary Development Landfill
#15 -- View of ditch on E. Side of
property as it meanders towards
wetlands area on SE side of GDC.
See #13.

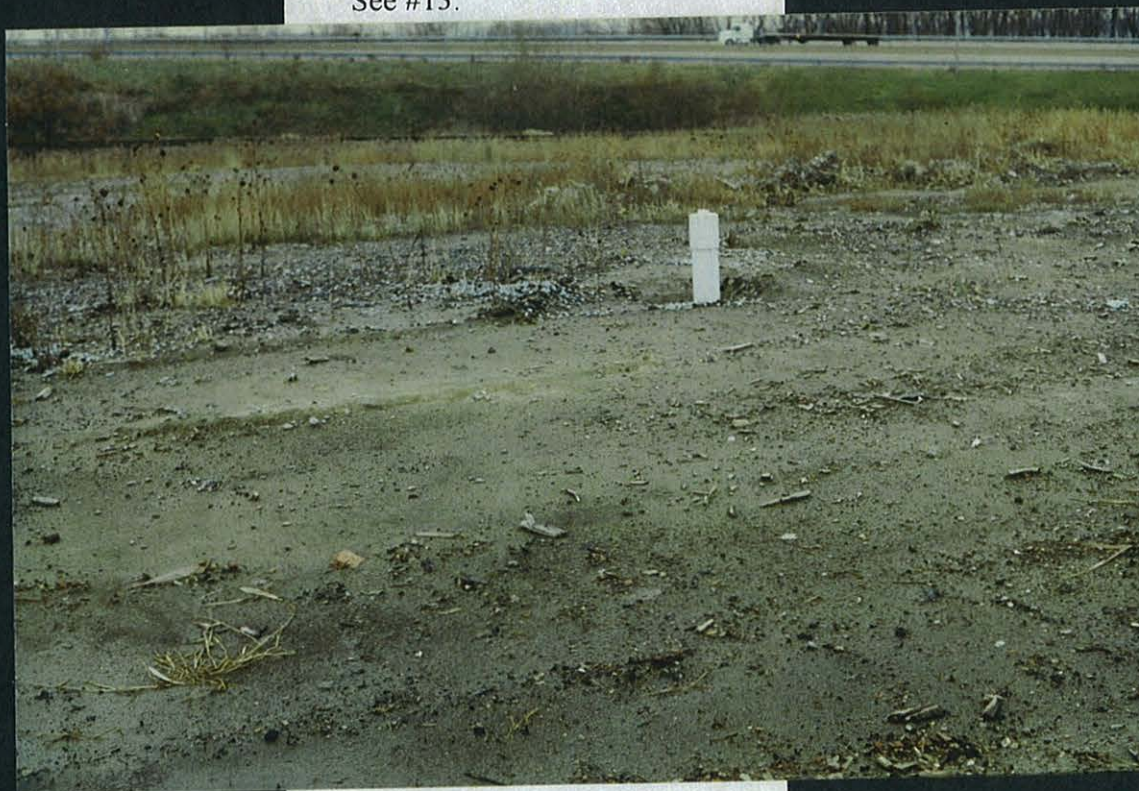
11-19-96 M. Mikulka
Gary Development Landfill
#16 -- gas recovery well (typical)
installed at GDC. Note lack of
vegetative cover on the landfill.

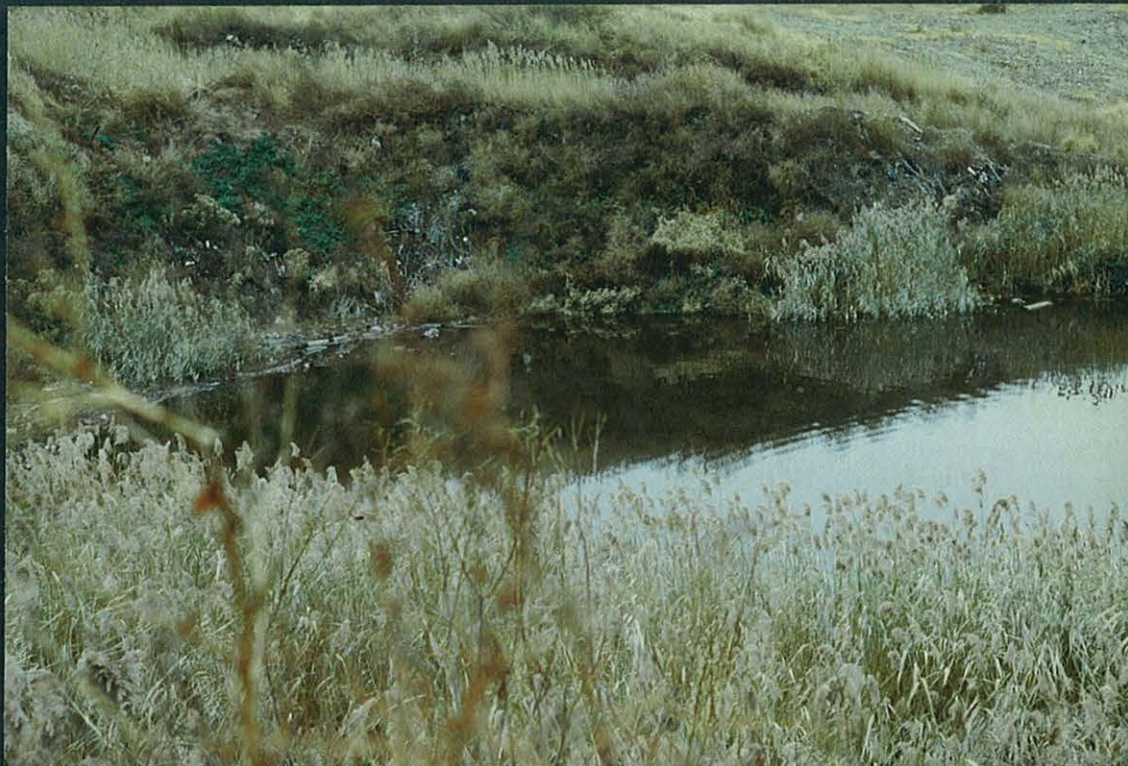
11-19-96 M. Mikulka
Gary Development Landfill
#17 -- eastern portion of
leachate/storm water collection
pond on north side of Property, as
viewed from north property
boundary.

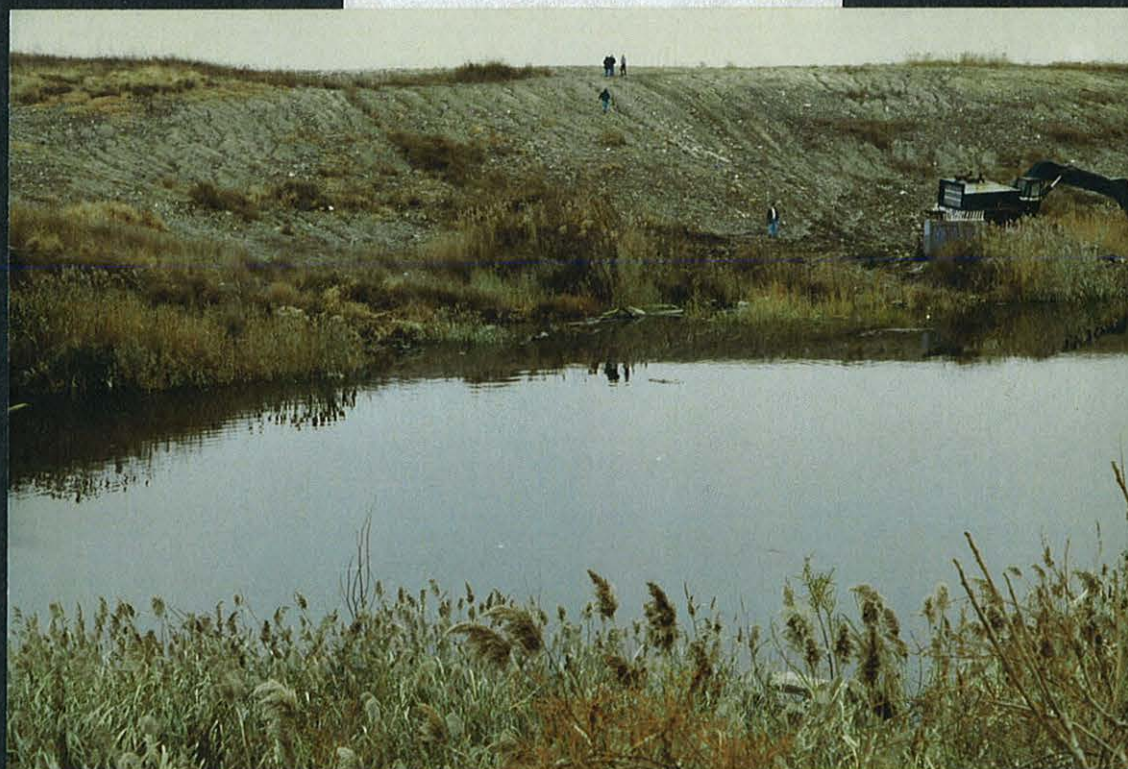
11-19-96 M. Mikulka
Gary Development Landfill
#18 -- View of central portion of
leachate/storm water collection

pond on north side of Property, as
viewed from north property
boundary. Shows north face of
landfill. Note lack of vegetative
cover and rill erosion.

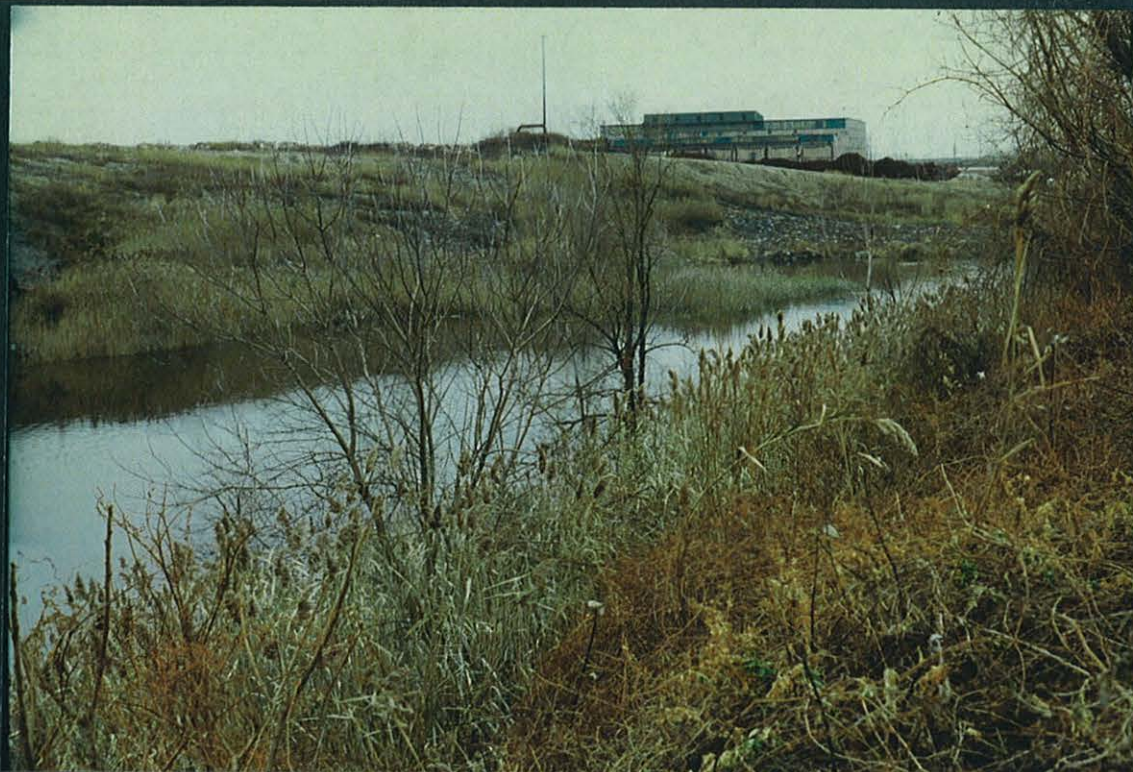
11-19-96 M. Mikulka
Gary Development Landfill
#19 -- View of western portion of
leachate/storm water collection
pond on north side of GDC

Property. Building in background
is AMG Resources facility, which
is due west of GDC site. At top of
pond, demolition debris can be
seen.

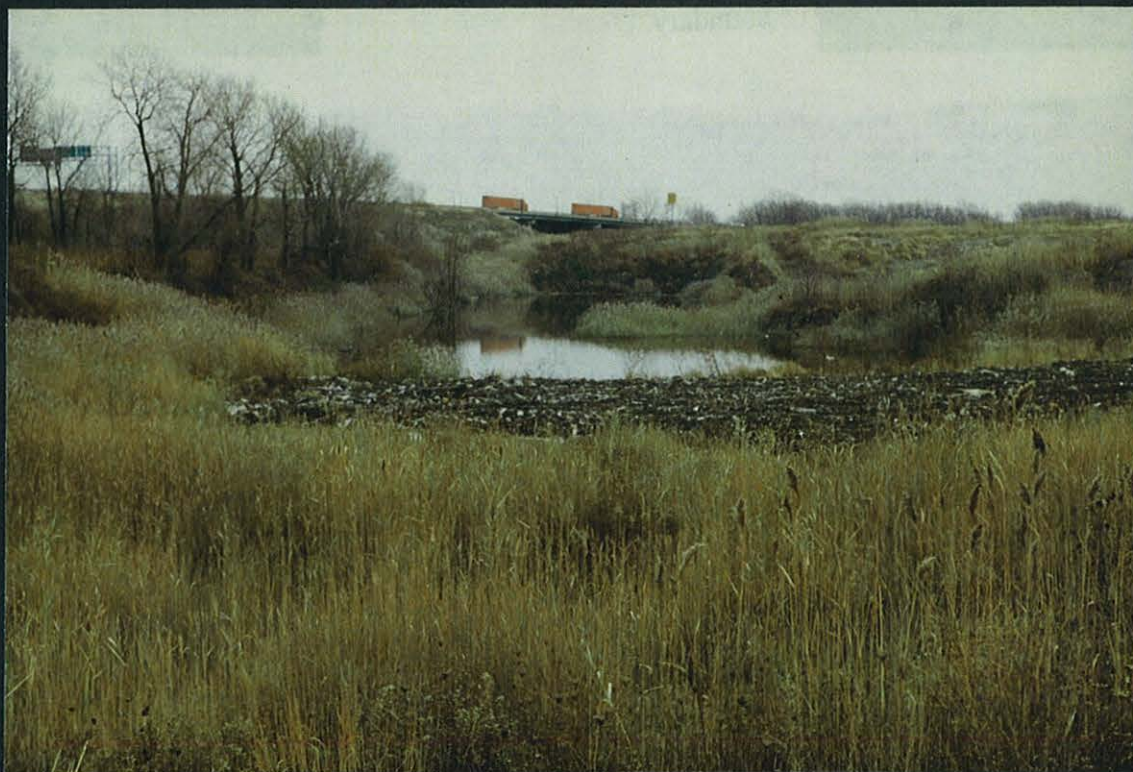
11-19-96 M. Mikulka
Gary Development Landfill
#20 -- View of leachate/storm
water collection pond on N. Side

of GDC Property, as viewed west
to east. Note Tollway exit ramp in
background.

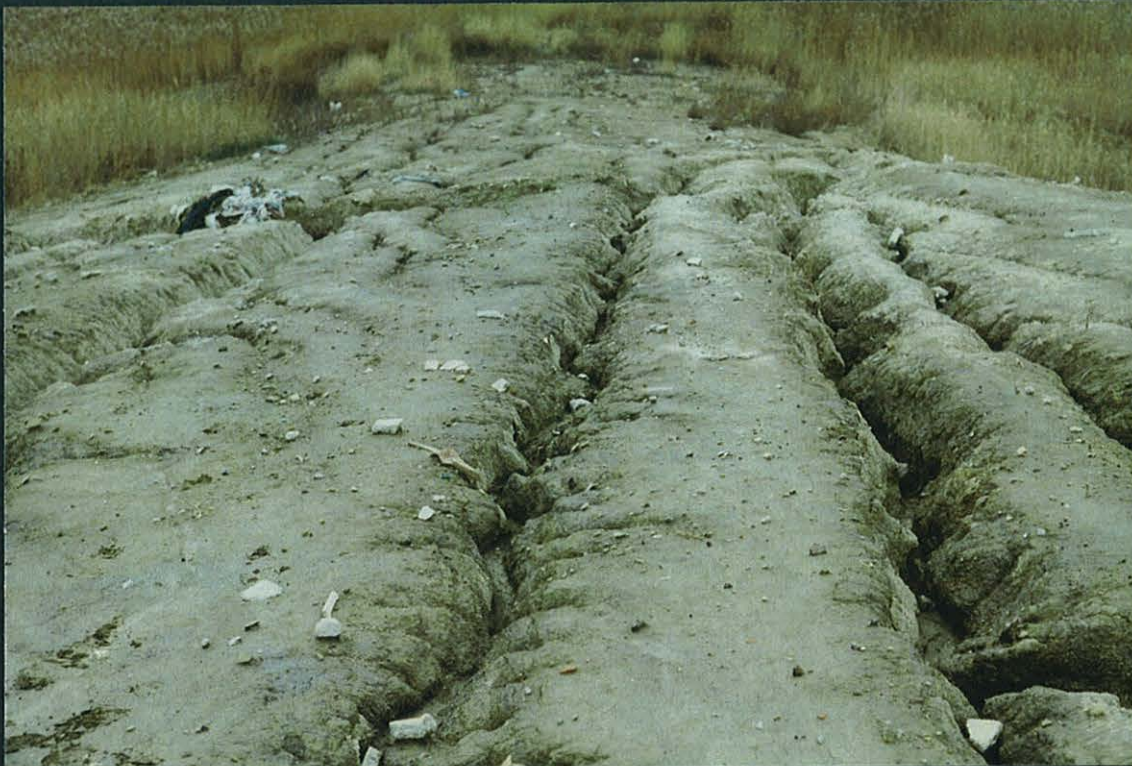
11-19-96 M. Mikulka
Gary Development Landfill
#21 -- View of western face of
GDC landfill, from top of landfill
and facing west. Note severe

erosion, cap material at toe of
slope, and trash from landfill.

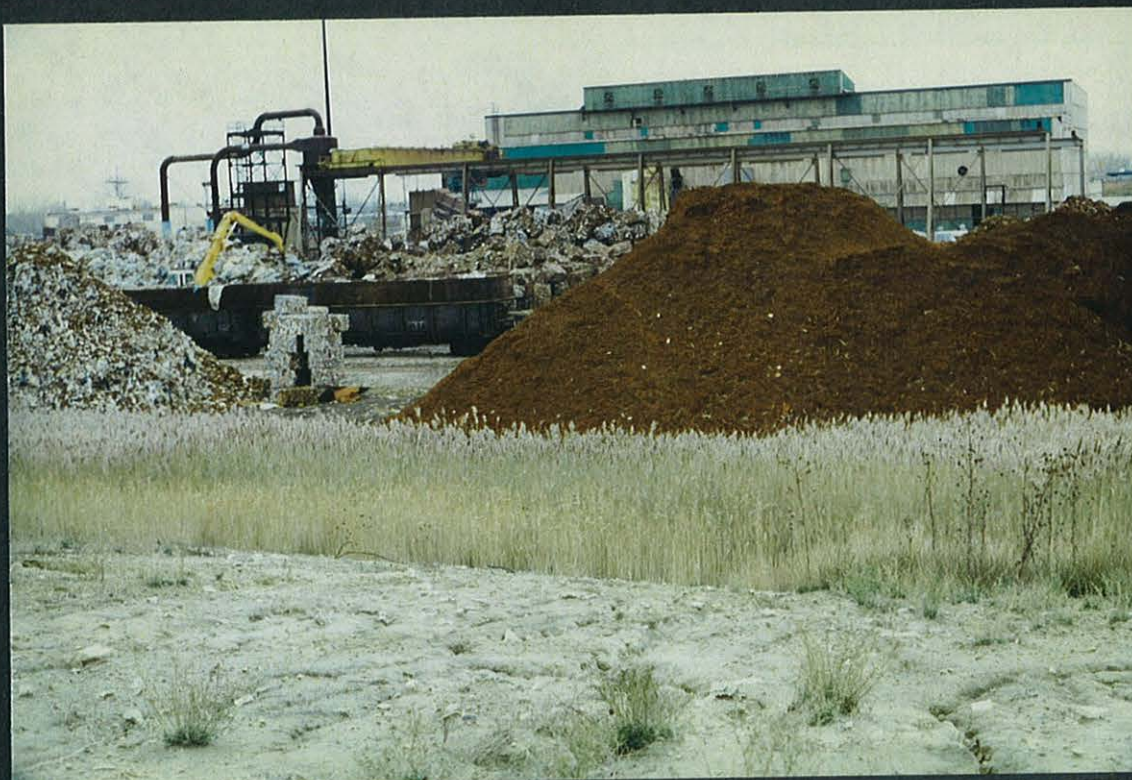
11-19-96 M. Mikulka
Gary Development Landfill
#22 -- View of AMG Resources
facility as seen from W. Side of
GDC Property. Note western face

of landfill in foreground, and
depressed area at toe of slope,
where storm water from western
portion of landfill drains.

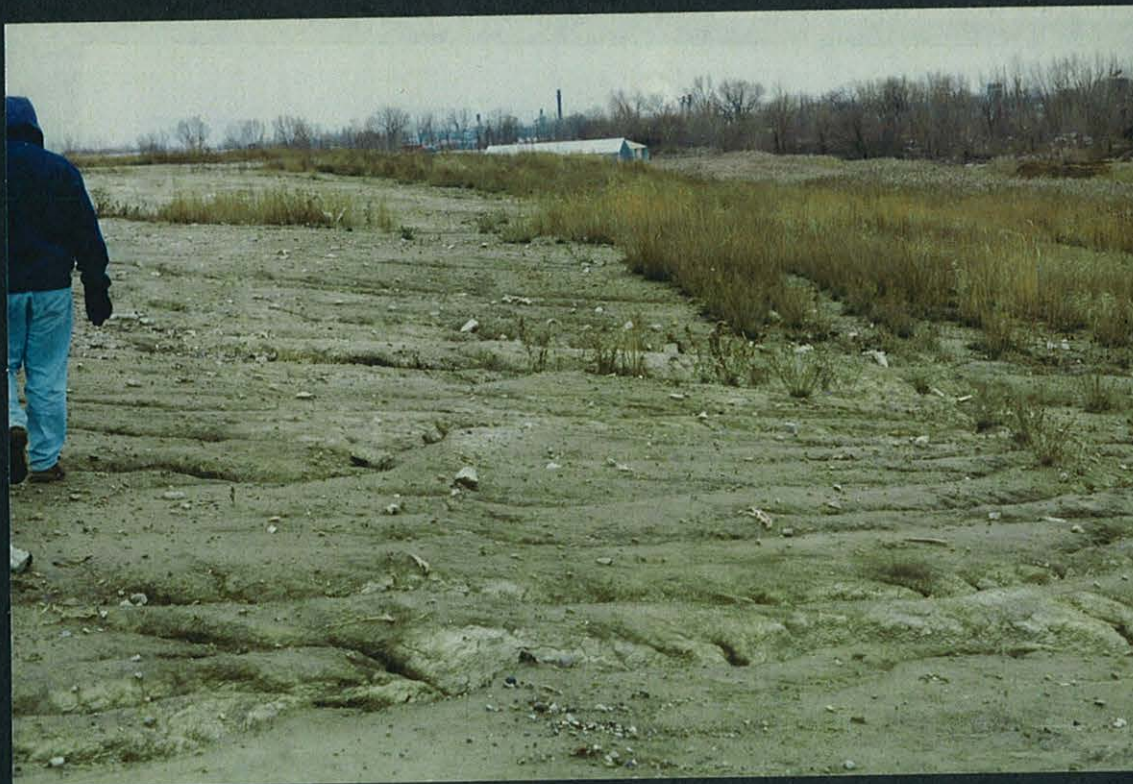
11-19-96 M. Mikulka
Gary Development Landfill
#24 -- View of western face of

GDC landfill as viewed from north
to south. Note GDC offices in
background. Note erosion
problem along complete face, and
lack of vegetative cover.
